**DEPARTMENT OF TRANSPORTATION**

Contract #: 04-0120F4Cty: SF/ALA Rte: 80 PM: 13.2/13.9File #: 69.28**WELDING INSPECTION REPORT****Resident Engineer:**Pursell, Gary**Address:** 333 Burma Road**City:** Oakland, CA 94607**Report No:** WIR-014379**Date Inspected:** 13-May-2010**Project Name:** SAS Superstructure**OSM Arrival Time:** 700**Prime Contractor:** American Bridge/Fluor Enterprises, a JV**OSM Departure Time:** 1900**Contractor:** Zhenhua Port Machinery Company, Ltd (ZPMC), Changxing Island **Location:** Shanghai, China**CWI Name:****CWI Present:****Yes No****Inspected CWI report:** **Yes No N/A****Rod Oven in Use:** **Yes No N/A****Electrode to specification:** **Yes No N/A****Weld Procedures Followed:** **Yes No N/A****Qualified Welders:** **Yes No N/A****Verified Joint Fit-up:** **Yes No N/A****Approved Drawings:** **Yes No N/A****Approved WPS:** **Yes No N/A****Delayed / Cancelled:** **Yes No N/A****Bridge No:** 34-0006**Component:** OBG Trial Assembly**Summary of Items Observed:**

Orthotropic Box Girder (OBG) Trial Assembly Areas

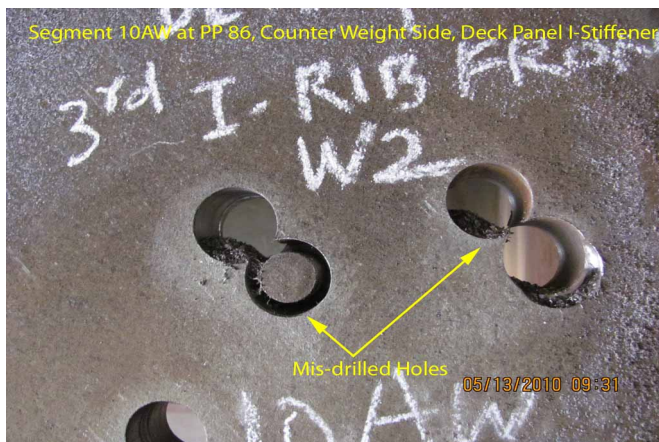
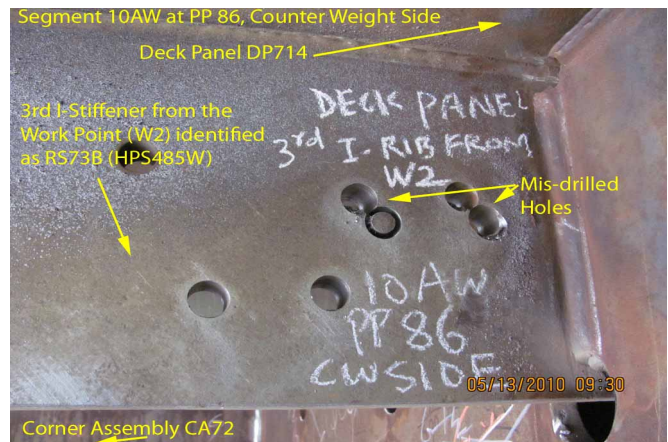
This Quality Assurance (QA) Inspector wrote an Incident Report for Mis-Drilled I-Stiffener of Deck Panel at Corner Assembly Counter Weight side at Panel Point (PP) 86 for Segment 10AW for more comprehensive details please refer the Incident Report # 04-0120F4\_TL-15\_B278\_05-13-2010\_Mis Drilled Holes\_Segment 10AW\_PP 86\_Deck Panel I-Rib at PP 86 Dated May 13, 2010. Please refer the attached pictures below for more comprehensive details.
